### Section 3. CHANNEL STABILITY

# UT to Dixon Branch

## Site 19

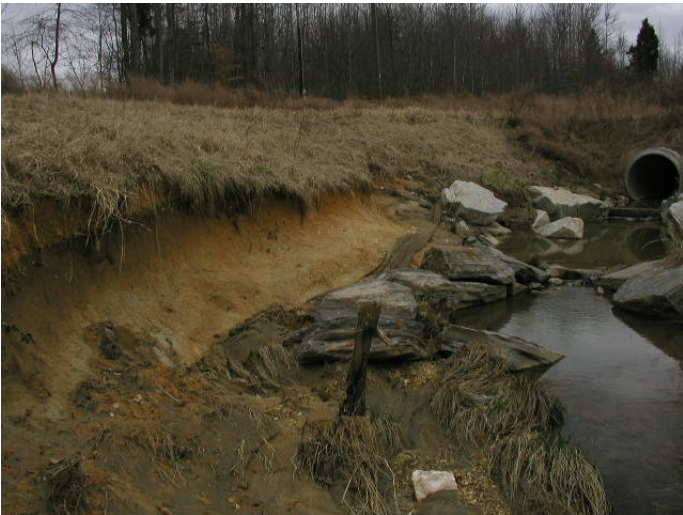
UT to Dixon Branch (Site 19) stream relocation is experiencing some instability for the Year 2 Winter evaluation. The right arm of the first crossvane at the outlet of the pipe (Sta 9+90 Y-7) has been displaced into the center of the channel. Also, downstream of the pipe the right bank has experienced some bank erosion at Sta. 9+80 Y-7. Two areas of bank scouring were noted upstream of the pipe crossing during this evaluation. NCDOT plans to perform remedial work at this stream relocation to repair the unstable areas.

Photo of right bank downstream of pipe

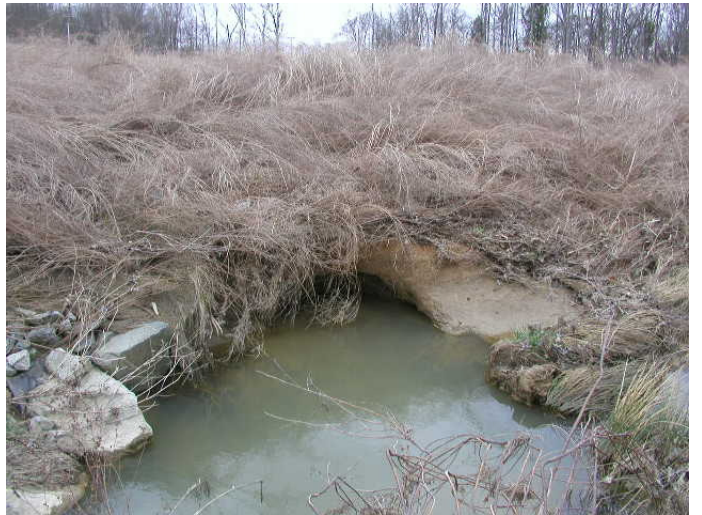
Left bank scouring at end of J-Hook @ Sta. 10+80 Y-7

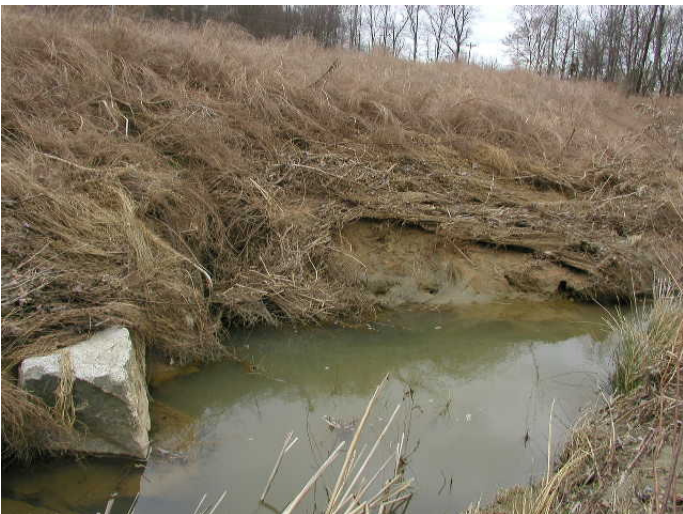
Left bank scouring at end of J-Hook @ Sta. 10+40 Y-7  
Year 2 Winter – March 2010
